**GILES COUNTY**  
PUBLIC SCHOOLS

**DIVISION WIDE FACILITY STUDY  
DECEMBER 2022**

**Crabtree, Rohrbaugh & Associates - Architects**  
250 West Main Street, Suite 200  
Charlottesville, VA 22902  
Virginia • Pennsylvania • Maryland • West Virginia

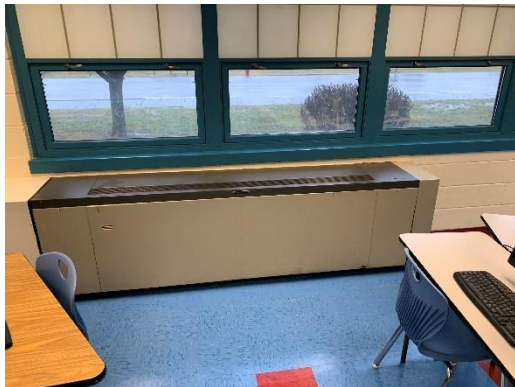
The existing building is served by a 4-pipe chilled water and hot water system that primarily utilizes unit ventilators and fan coils to serve the HVAC loads of the spaces/zones. The ventilation for the educational wing of the building is provided by dedicated outside air systems (DOAS) located on the roof(s) that have DX cooling coils, hot water heating coils, and energy recovery wheels. There are some larger spaces, such as the gym, that utilize four pipe blower coils to condition the space loads and the ventilation air is provided by a rooftop DOAS unit.

*Typical Unit Ventilator - Classroom*

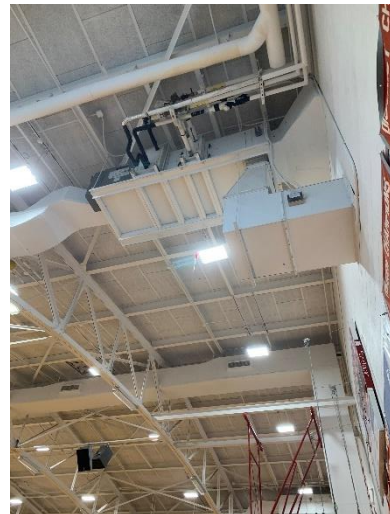
*Typical Blower Coil - Gymnasium*

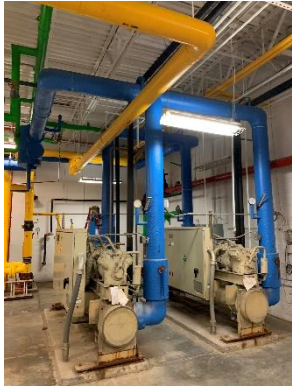
The existing central plant is made up of two 97.5-ton split DX air-cooled chillers and two 1,600MBH natural gas boilers. The chillers, boilers, and associated pumps are located in the lower-level main mechanical room adjacent to the gymnasium, and the split DX condensers for the chillers are located on the roof above the gym storage area. A majority of the central plant equipment is from the previous 1999/2000 HVAC renovation that replaced the old coal-fired steam boiler system and unit ventilators.

*Existing Chillers*

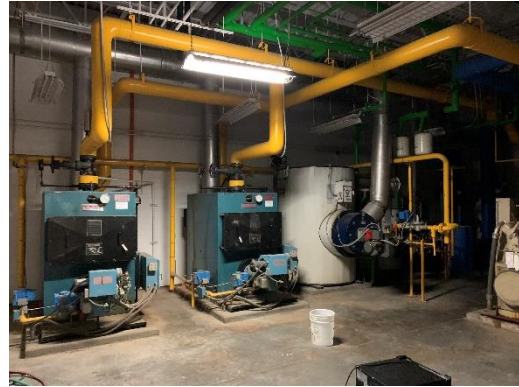
*Existing Gas Fired Boilers*

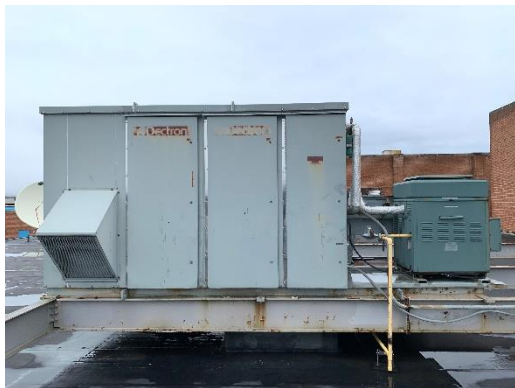
A majority of the ventilation air for the school building is provided by dedicated rooftop outside air units that were installed during the 1999/2000 HVAC renovation. The units are custom Dectron energy recovery units that have a DX cooling coil and a hot water heating coil. The units are installed on exterior structural dunnage that also supports a split DX condenser and natural gas-fired heating water boiler. Each DOAS unit has its own dedicated split DX condenser and heating water boiler which is a maintenance issue which should be addressed no matter the final central plant solution that is chosen.

*Typical Built-Up DOAS*

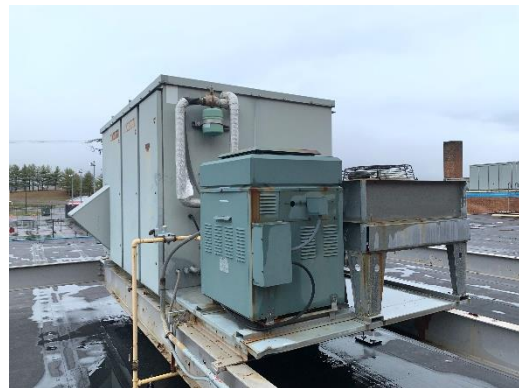
*Typical Built-Up DOAS*

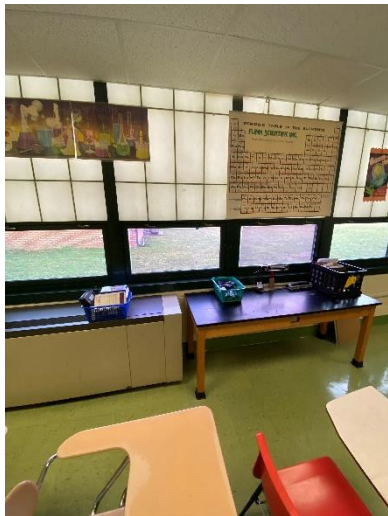
The existing building is served by a 4-pipe chilled water and hot water system that primarily utilizes unit ventilators and fan coils to serve the HVAC loads of the spaces/zones. The ventilation for the educational wing of the building is provided by dedicated outside air systems (DOAS) located on the roof(s) that have DX cooling coils, hot water heating coils, and energy recovery wheels. There are some larger spaces, such as the gym, that utilize four pipe blower coils to condition the space loads and the ventilation air is provided by a rooftop DOAS unit.

*Typical Unit Ventilator - Classroom*

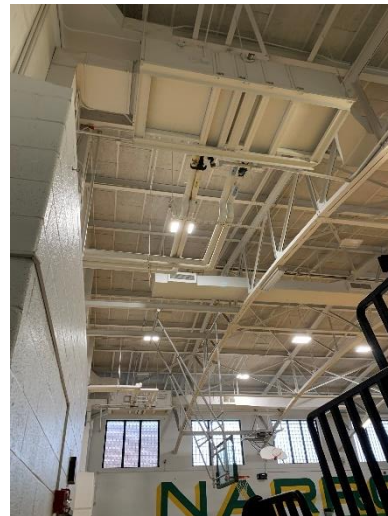
*Typical Blower Coil - Gymnasium*

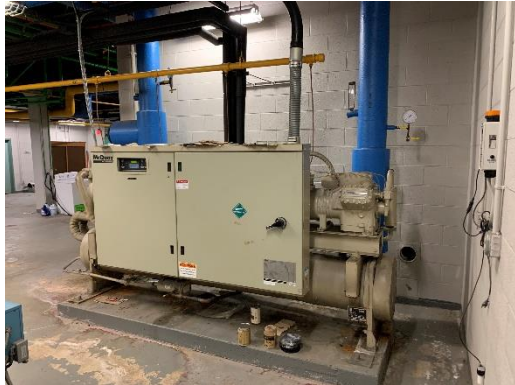
The existing central plant is made up of one 133-ton split DX air-cooled chiller and two 1,200MBH natural gas boilers. The chillers, boilers, and associated pumps are located in the lower-level main mechanical room adjacent to the gymnasium, and the split DX condensers for the chillers are located on the roof above the gym storage area. A majority of the central plant equipment is from the previous 1999/2000 HVAC renovation that replaced the old coal-fired steam boiler system and unit ventilators.

*Existing Chiller*

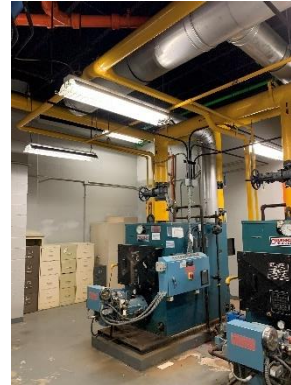
*Existing Gas Fired Boilers*

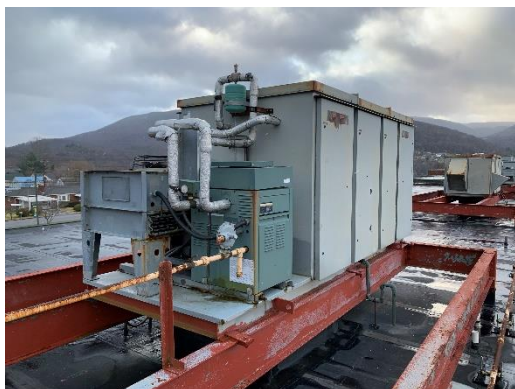
and a hot water heating coil. The units are installed on exterior structural dunnage that also supports a split DX condenser and natural gas-fired heating water boiler. Each DOAS unit has its own dedicated split DX condenser and heating water boiler which is a maintenance issue which should be addressed no matter the final central plant solution that is chosen.

*Typical Built-Up DOAS*

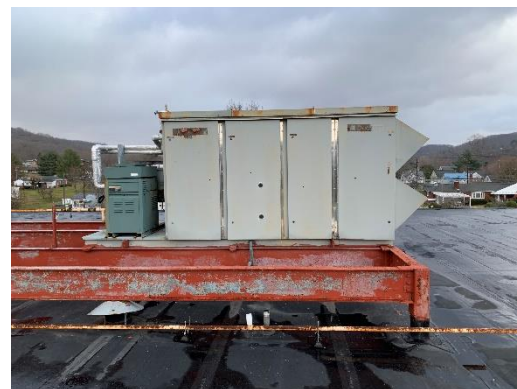
*Typical Built-Up DOAS*

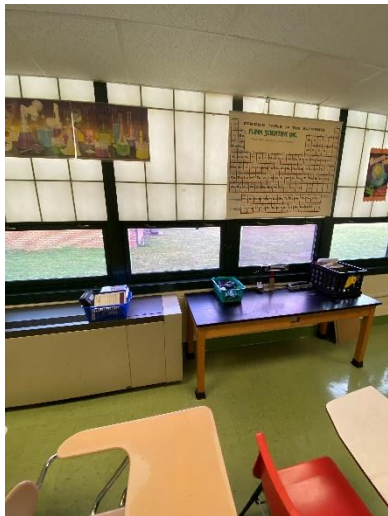
The existing building is served by a 4-pipe chilled water and hot water system that primarily utilizes fan coils to serve the HVAC loads of the spaces/zones. The ventilation for the educational wing of the building is provided by energy recovery ventilators (ERVs) located on the roof(s) that have no heating or cooling coils but rather utilize energy recovery wheels to pretreat the ventilation air that is being mixed with the return air to the fan coil units. There are some larger spaces, such as the gym, that utilize four pipe blower coils to condition the space loads and the ventilation air is provided by a rooftop DOAS unit.

*Typical Unit Ventilator - Classroom*

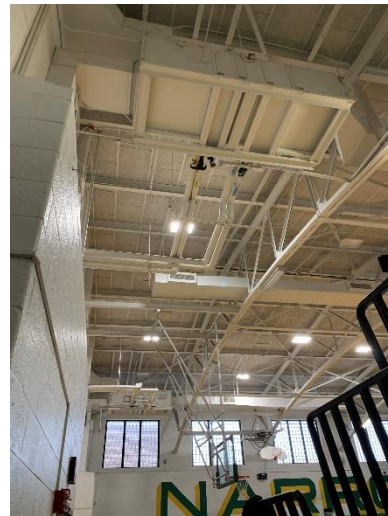
*Typical Blower Coil - Gymnasium*

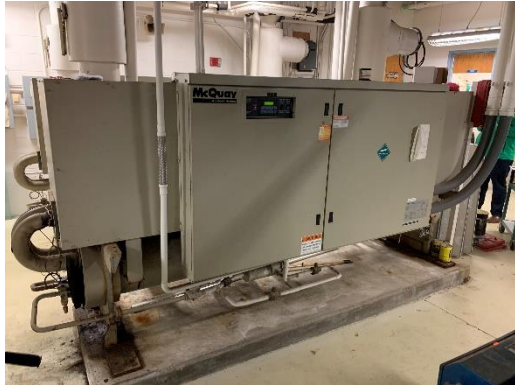
The existing central plant is made up of two 130-ton split DX air-cooled chillers and two 2,300MBH natural gas boilers. The chillers, boilers, and associated pumps are located in the lower-level main mechanical room adjacent to the gymnasium, and the split DX condensers for the chillers are located on the roof above the gym storage area. A majority of the central plant equipment is from the previous 1999/2000 HVAC renovation that replaced the old coal-fired steam boiler system and unit ventilators.

*Existing Chiller – 1 of 2*

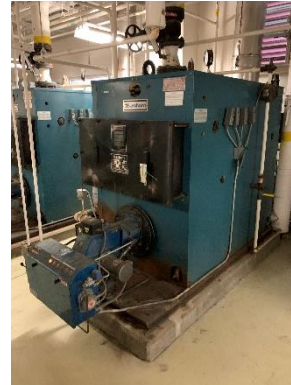
*Existing Gas Fired Boiler – 1 of 2*

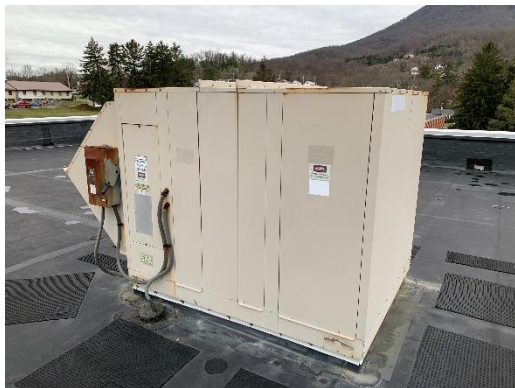
A majority of the ventilation air for the school building is provided by dedicated rooftop energy recovery ventilators that were installed during a previous HVAC renovation. The units are Des Champs PVEZW units that have a total enthalpy wheel, a supply fan, and an exhaust fan. The units are installed on standard roof curbs. The ERVs cannot adequately control temperature and/or humidity as there are no active coils in the unit which could help to reduce humidity in the air, which can lead to issues within the occupied spaces and this should be addressed no matter the final central plant solution that is chosen.

*Typical ERV*

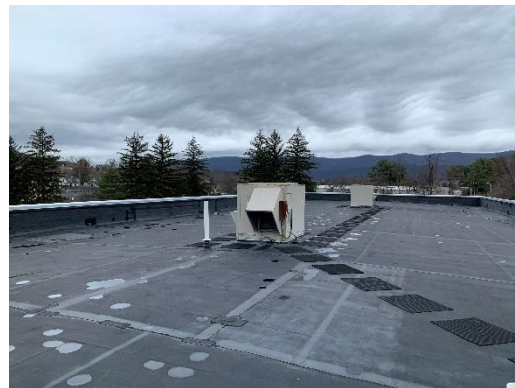
*Typical ERVs*
